**University of Hull Photovoltaic  
Project, Hull Road – BS  
5837:2012 Arboricultural  
Report, Impact Assessment  
and Method Statement  
Gardiner and Theobald LLP**

**Report Title:** University of Hull Photovoltaic Project, Hull Road –  
 BS5837:2012 Tree Survey, Arboricultural Impact Assessment  
 and Arboricultural Method Statement

**Version:** V2.0  
**Issue Date:** September 2022  
**Report Ref:** 18618C

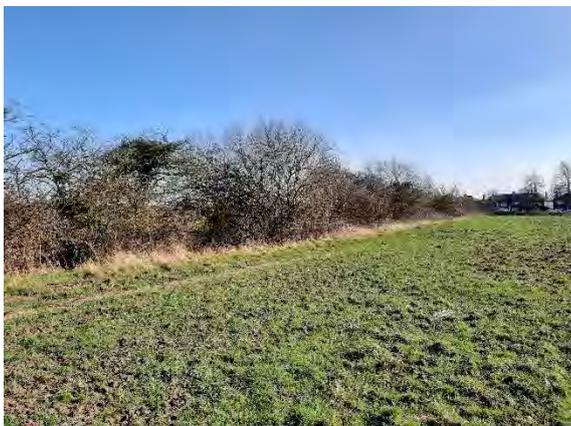
**Plate 1:** G001 from the north west

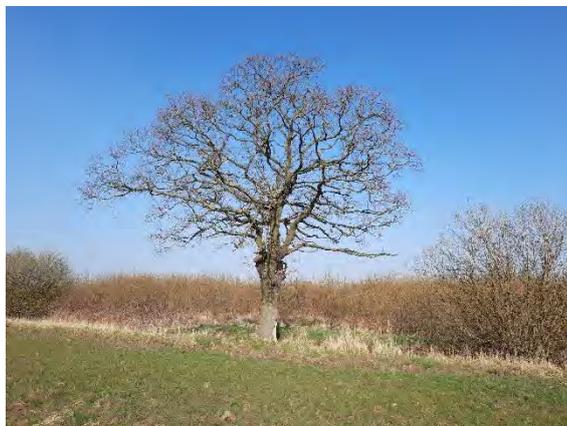
**Plate 2:** T002 from the west

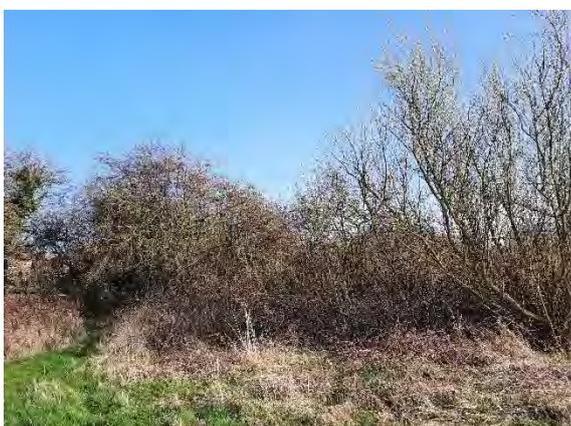
**Plate 3:** Section of G006 that will need to be removed, from the north

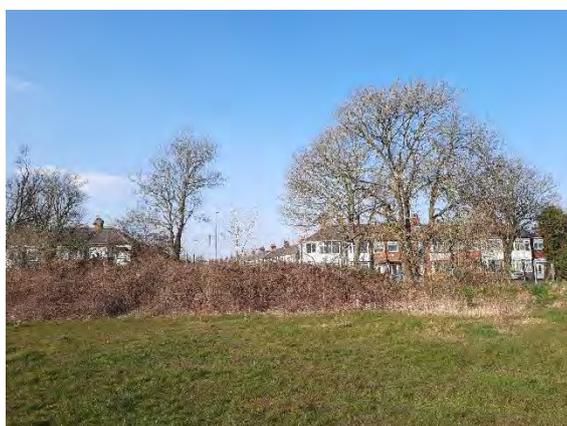
**Plate 4:** T010, T021 to T024 and G025 from the south

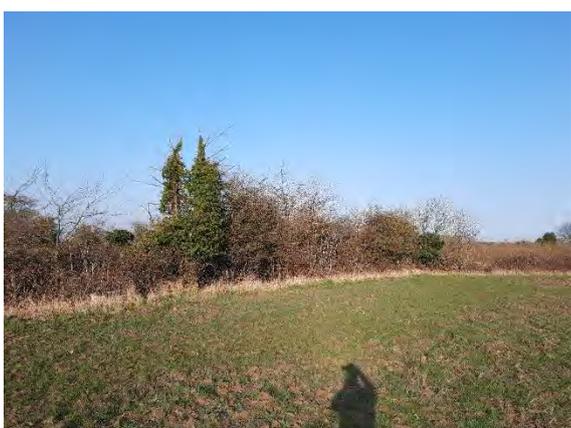
**Plate 5:** G016 and G017 from the south west

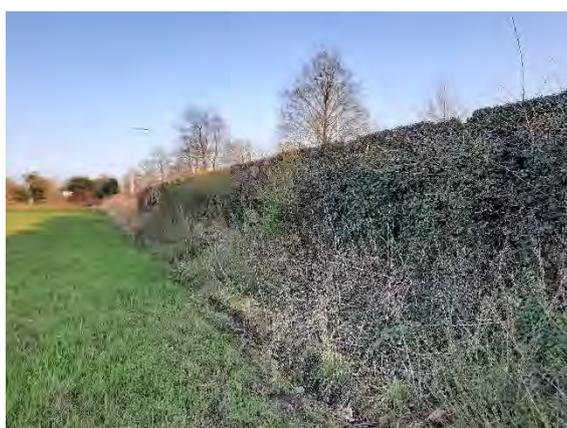
**Plate 6:** H019 from the north

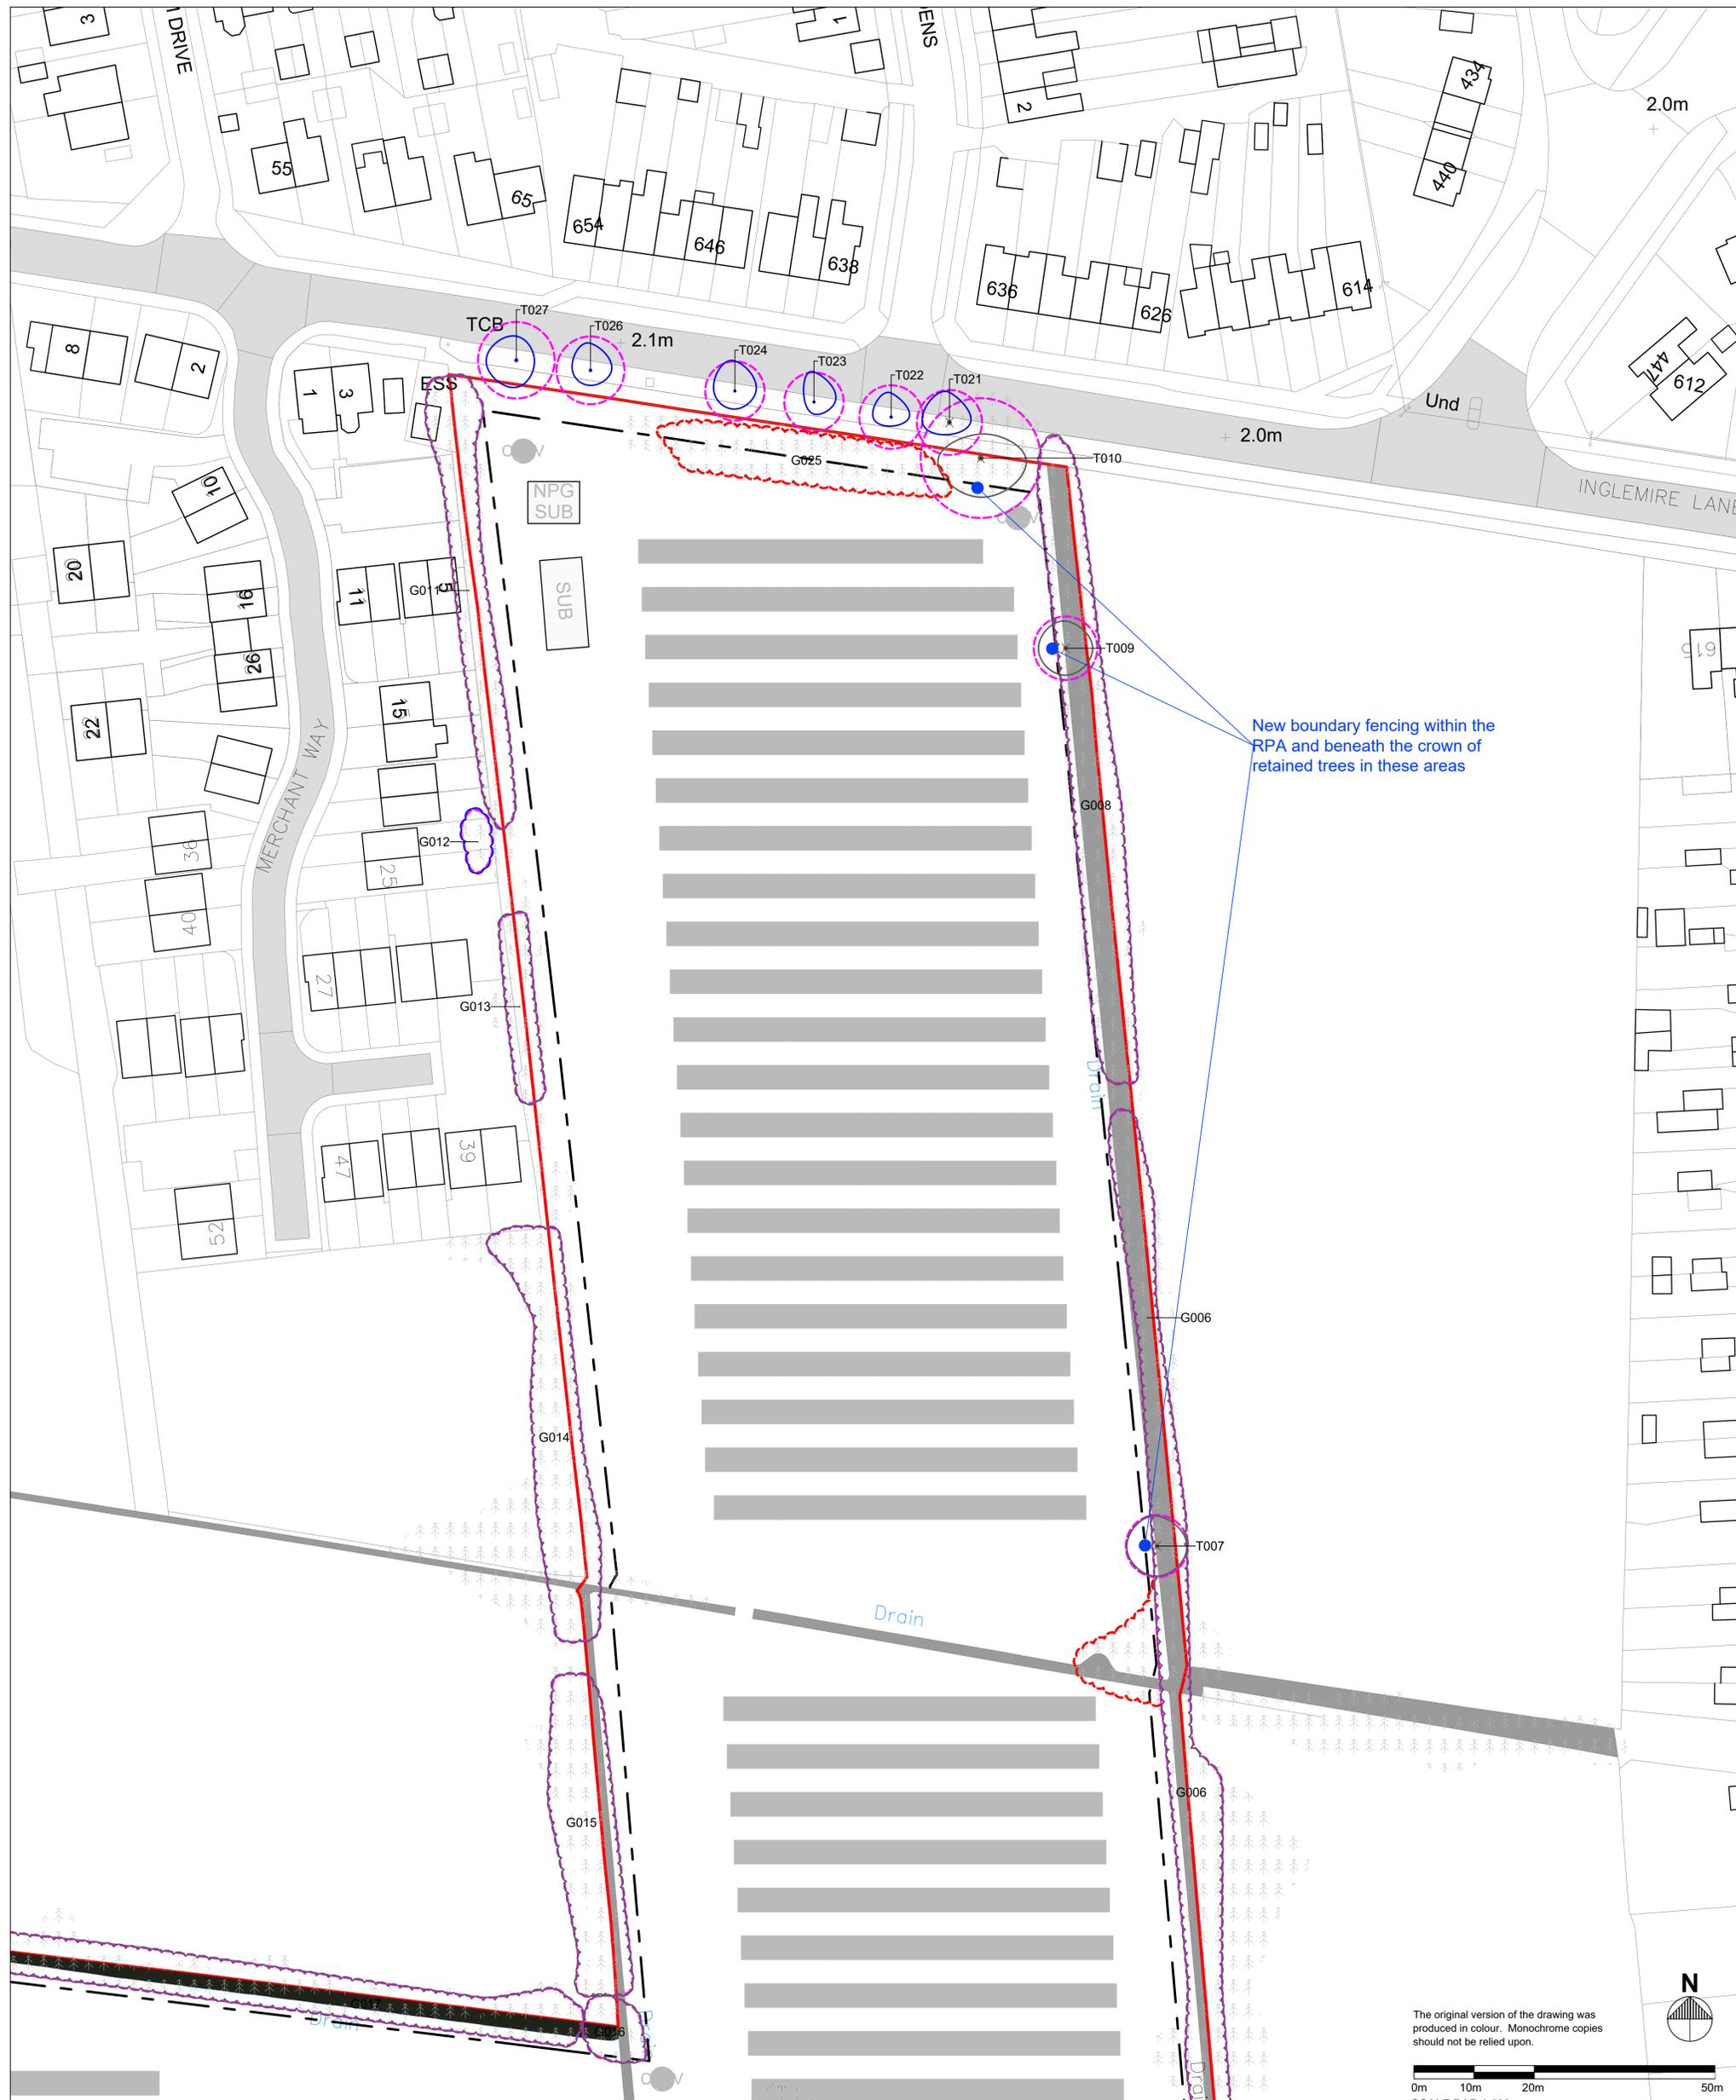
Title: Figure 8 - Tree Impacts Plan (Sheet 2 of 3)

New boundary fencing within the RPA and beneath the crown of retained trees in these areas
